REPORT OF INVESTIGATION

Fatal Fall of Roof Accident  
June 16, 2004

Coal Creek  
Bell County Coal Corporation  
Middlesboro, Bell, Kentucky  
ID No. 15-18058

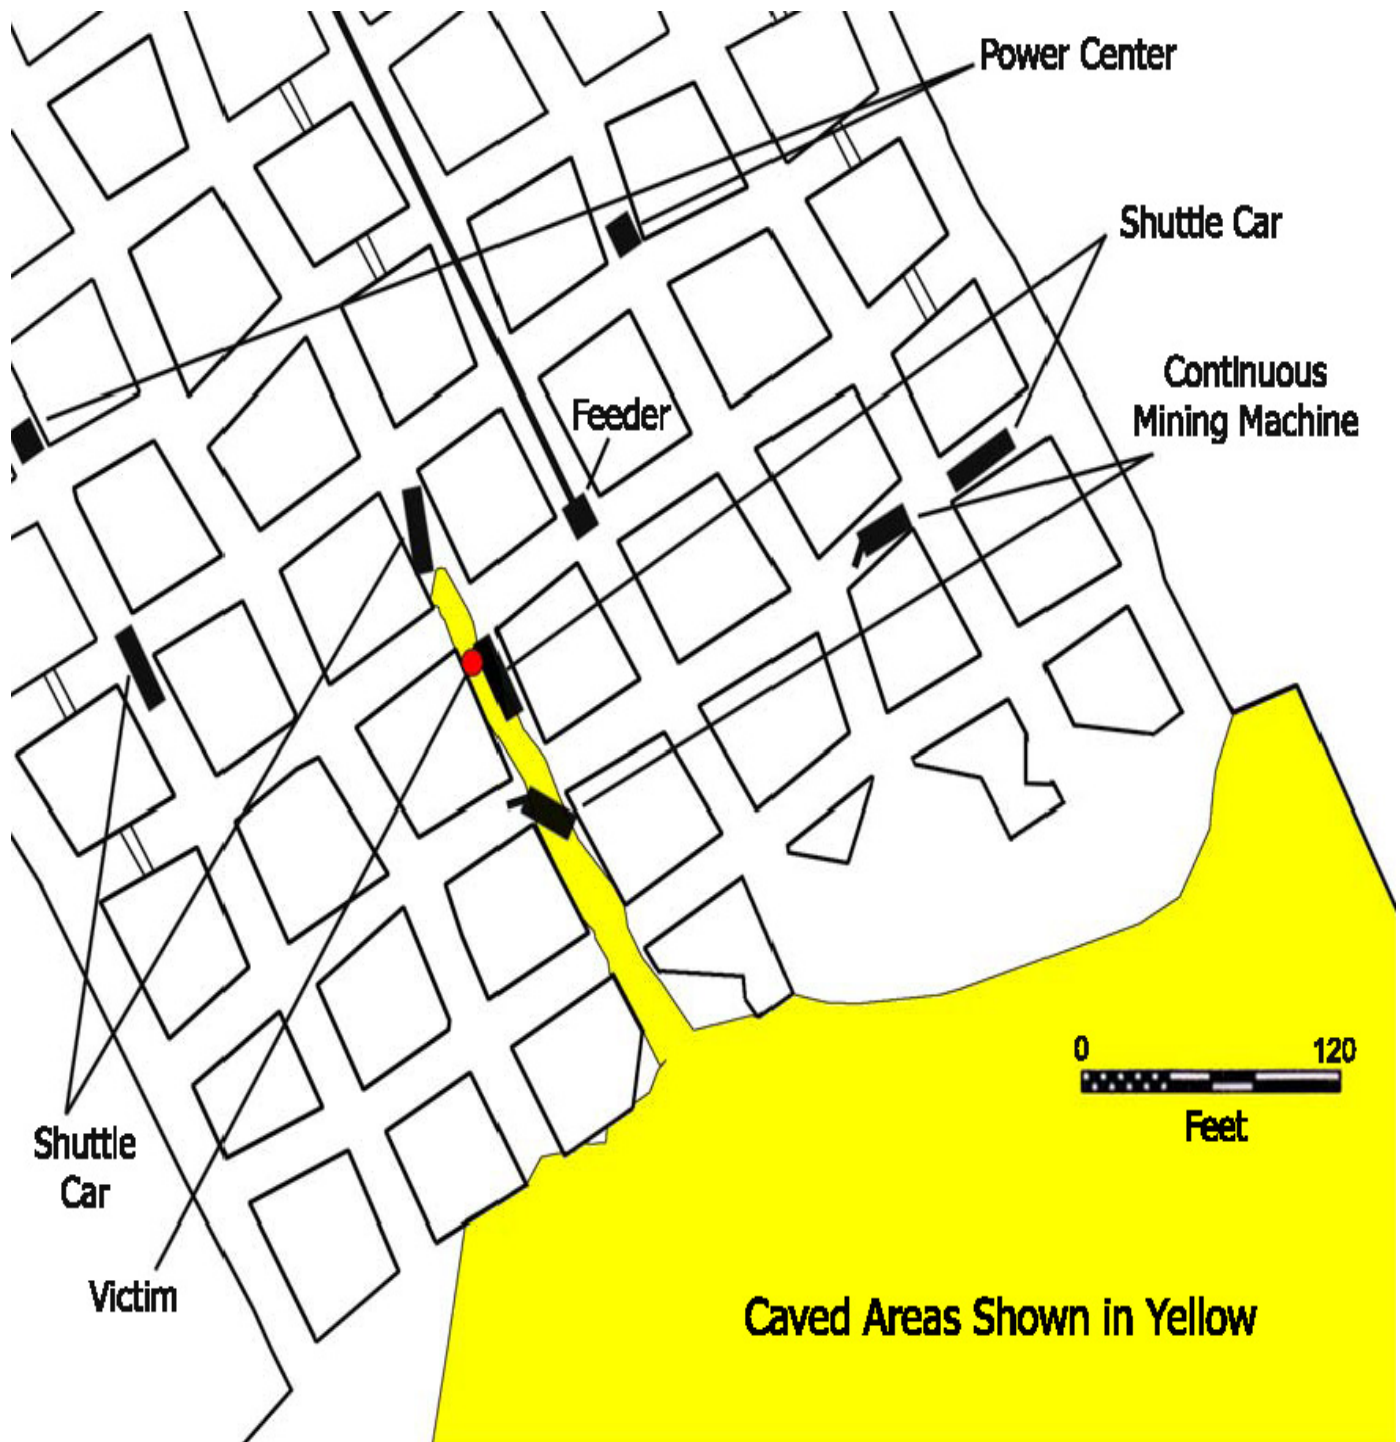
# ACCIDENT SITE

The roof fall ranged from four to six-plus feet in thickness, 12 to 20 feet in width, and was approximately 210 feet in length from the pillar line. The entire roof fall was bounded on the east (right) by a near vertical joint system (hillseam) along the rib line of the No. 5 entry and the fall was bounded on the west (left) by a parallel near vertical joint system (hillseam) along the opposite rib line of the No. 5 entry. The joints trend at N30°W to N33°W, near parallel to the No. 5 entry.

A parallel joint system (hillseams) was present in the No. 5 entry and extended into the worked out area as determined by visual examination. This parallel joint system initiated the fall near the pillar line and then allowed the fall to propagate along the No. 5 entry

outby the mining area. The fall terminated on a N27°E joint plane 16 feet outby spad number 3862. Inadequately supported roof in an entry containing two parallel joints (hillseams) was a contributing factor to the fatal roof fall. It appears that regardless of the retreat mining sequence, the normal progression of the caving roof in the worked out area and the associated stress transfer would have impacted the entry containing the two parallel joints, resulting in the roof fall.

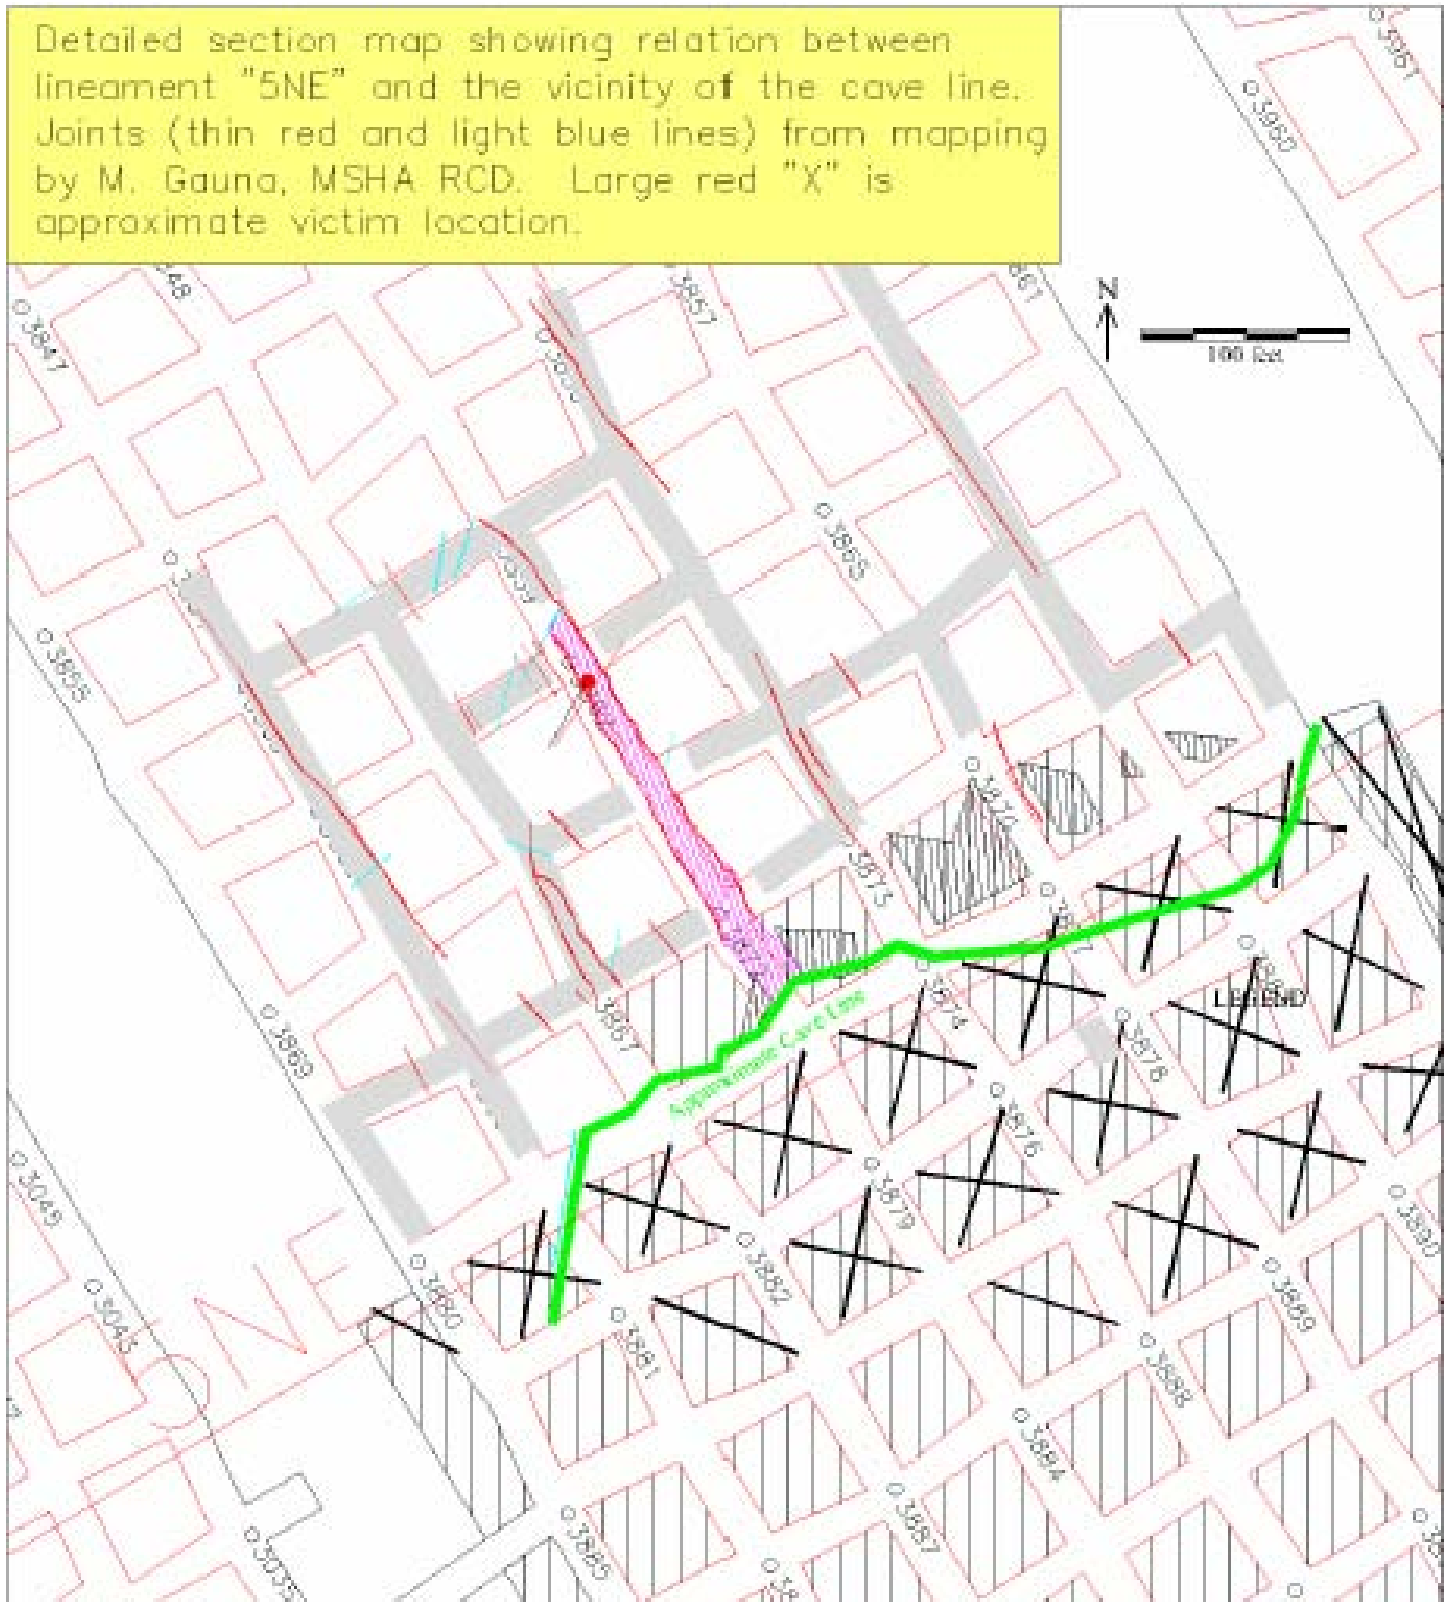
## Appendix B

Other near vertical open joints existed on the section. In the other entries in the face area, a primary joint system, similar in orientation to the system controlling the roof fall, ranged from N28°W to N38°W in orientation. A less pronounced, secondary joint system also existed, oriented N12°E to N57°E. This secondary joint system was only evident in the No. 5 and No. 6 entries two to three crosscuts outby the pillar line. The only role the secondary joint system played in the roof fall was that it allowed the fall to terminate on one of its N27°E joint planes. See Appendix B.
